Orpheum Theatre Terra Cotta/Masonry Restoration

Hennepin Avenue
Minneapolis, Minnesota

Building Management Report

July 25, 2003

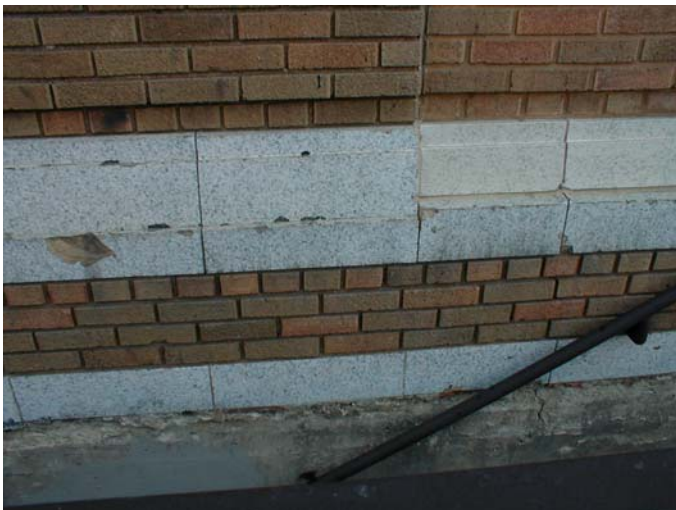
Fig.52: Damaged terra cotta water table at exit area-way along Hawthorne Avenue.

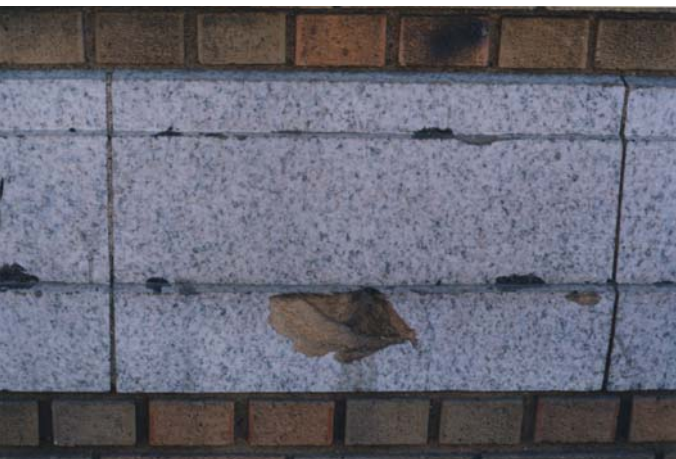
Fig.53: Enlarged view of damaged terra cotta water table unit.

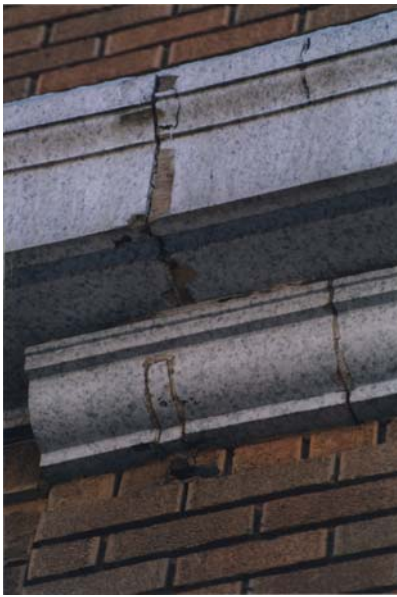
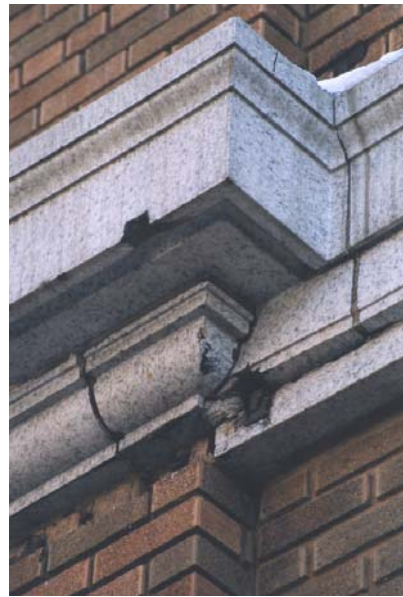
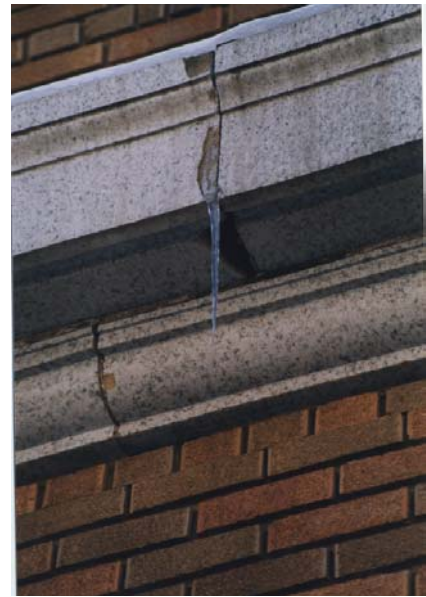
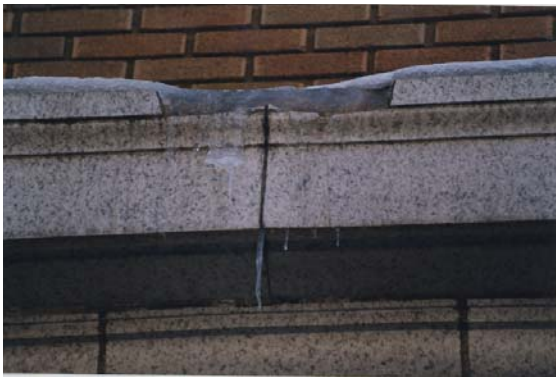
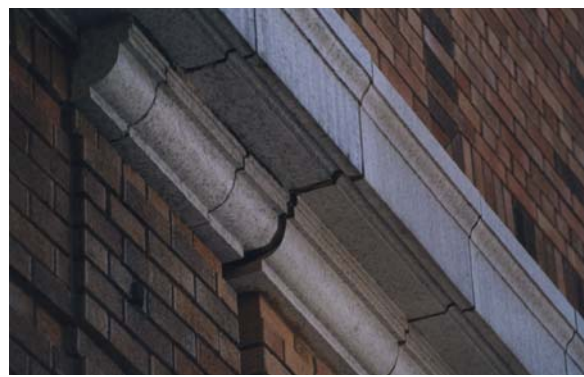
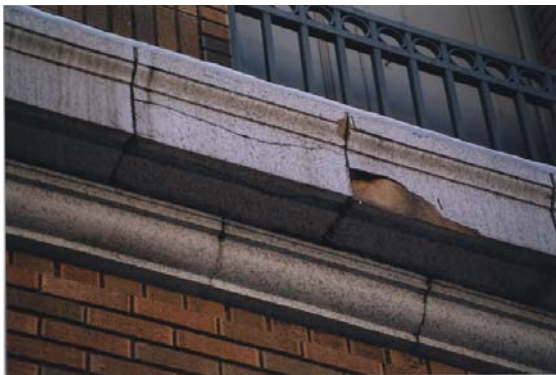
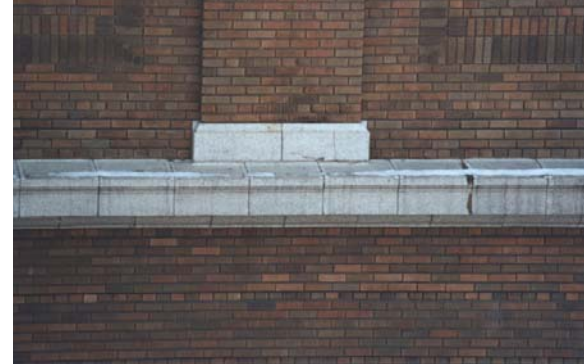
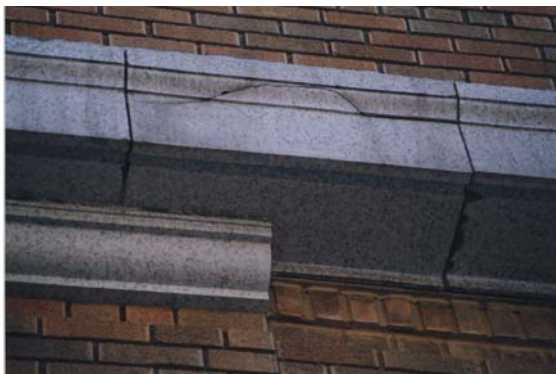
Fig.54-61: Damaged terra cotta dripstone units along Hawthorne Avenue that were assigned a C-Level Priority rating.
